Healthy Port Futures

PORT BAY

SEDIMENT ENGINE

a report summarizing the landscape research, implementation,
and monitoring of the Port Bay Sediment Engine

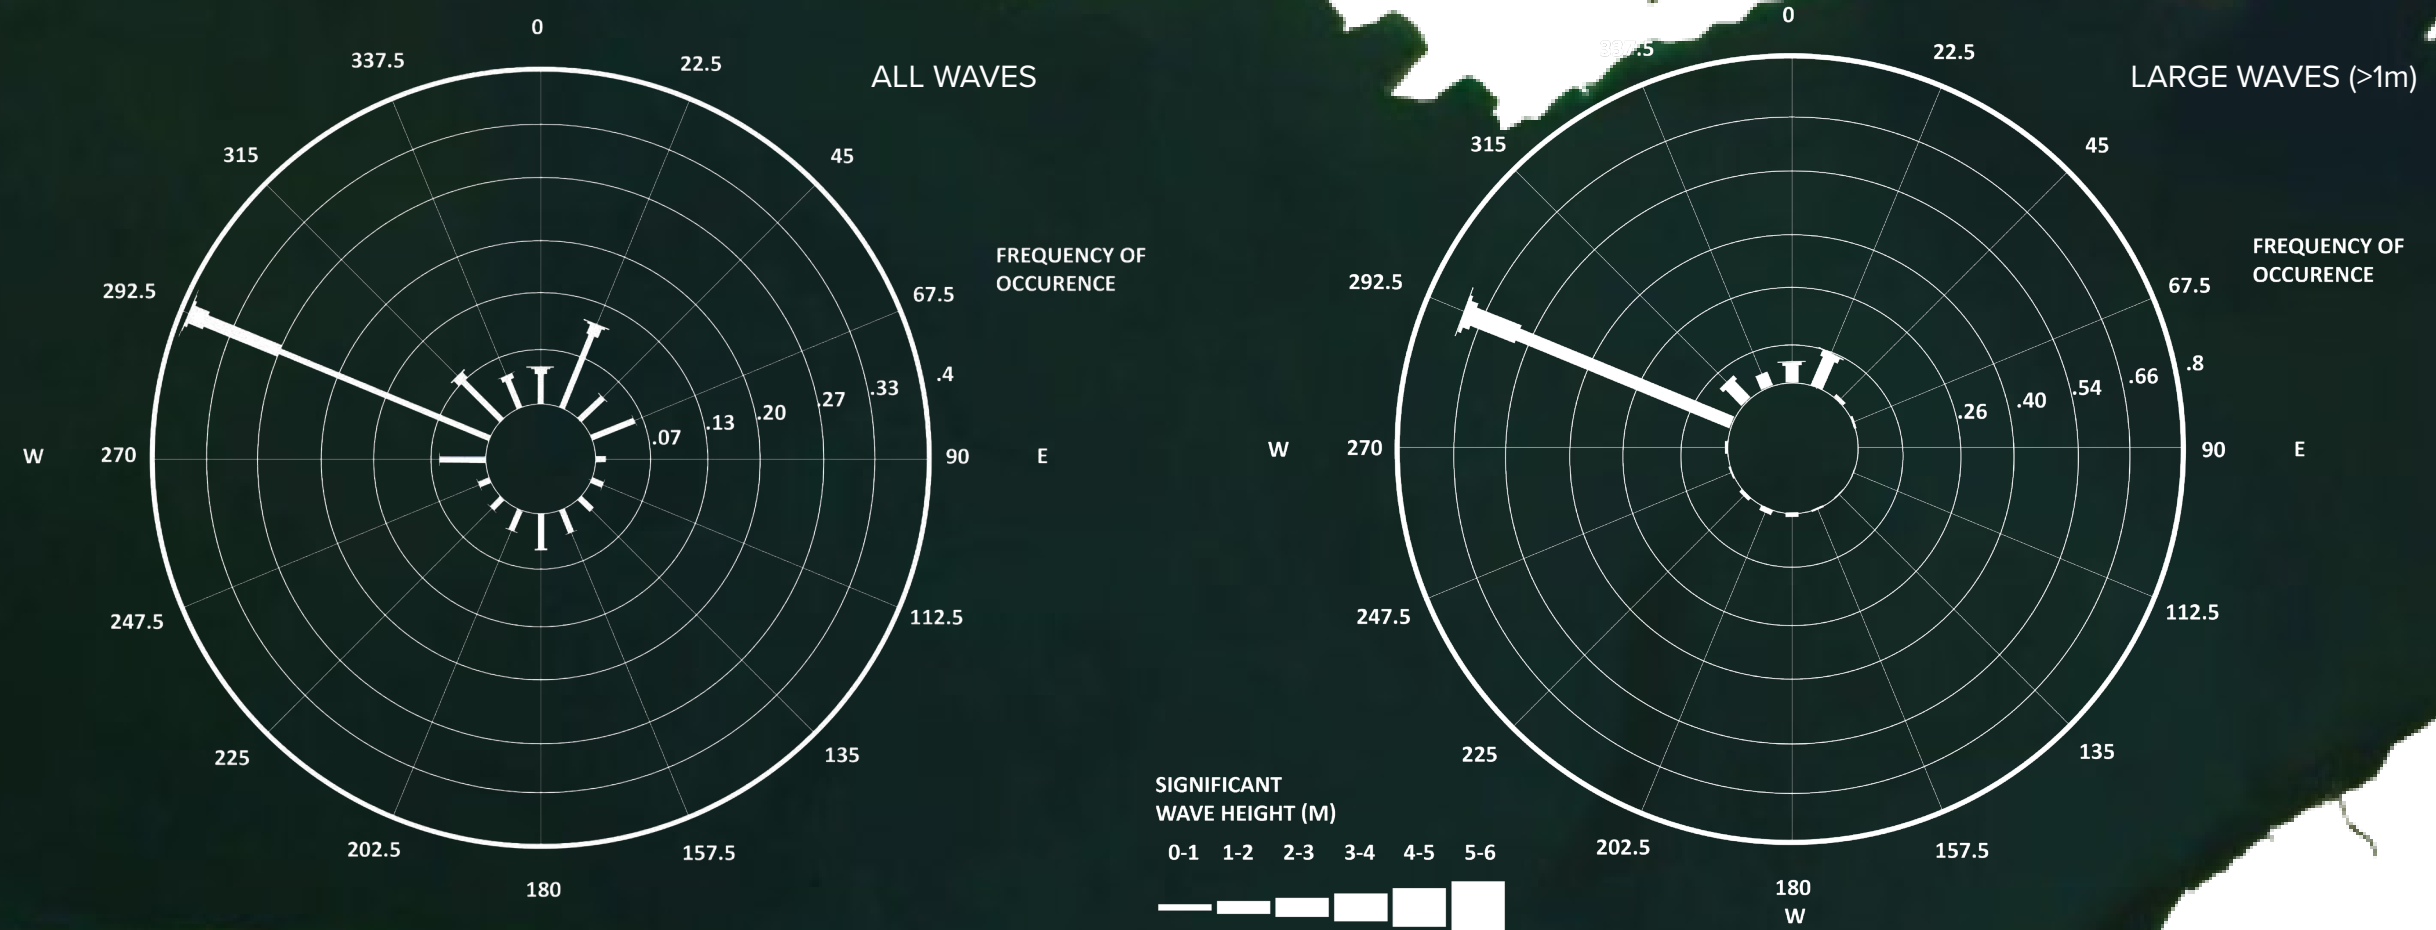
Figure 3.1 April Wave Classes

The larger waves (>1m) move the coarser gravel and cobble sediment. During April, the larger waves (>1 m at the buoy) were predominantly (72%) from the western- northwestern direction (292.2) (Figure 3.1) While nor'easters do happen, as seen in spring 2016, which led to the major breach, they occur much less frequently. Only eight percent of the larger waves during April come from the northeast. In conclusion, the majority of the waves that would move the coarse dredge material are from the northwest direction. These calculations were considered during the research and placement of the dredge material.

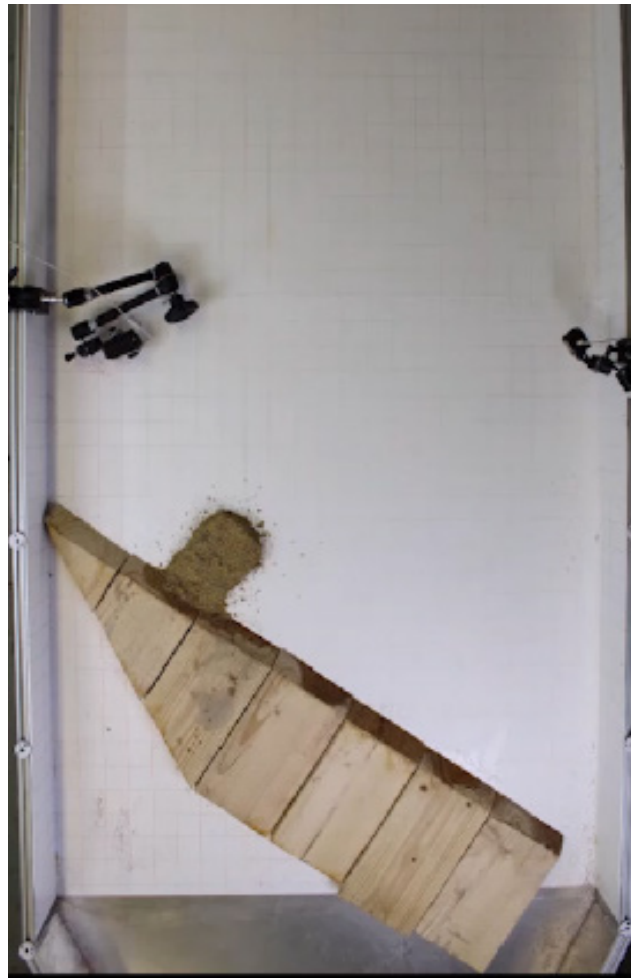
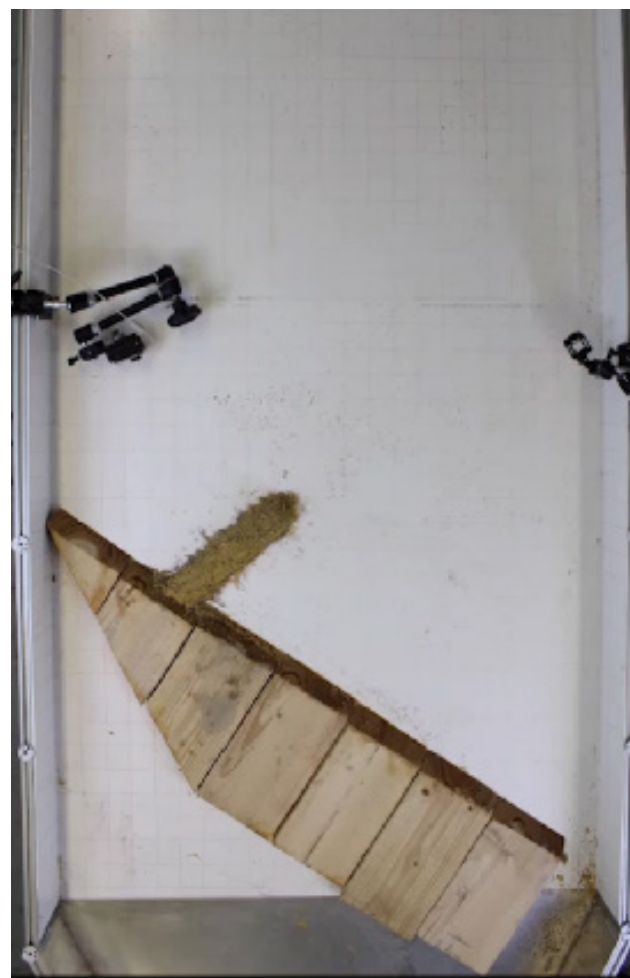
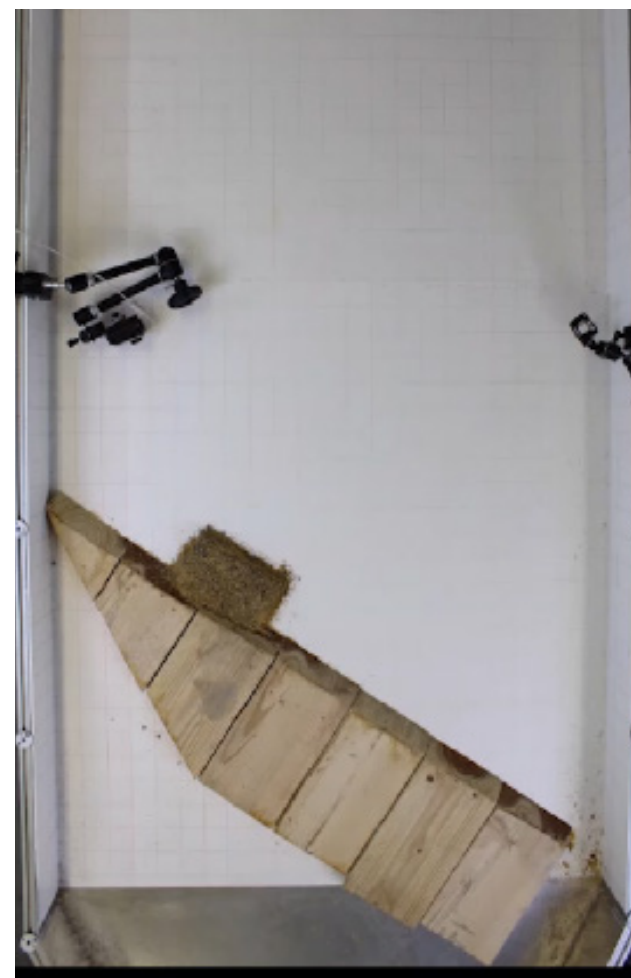
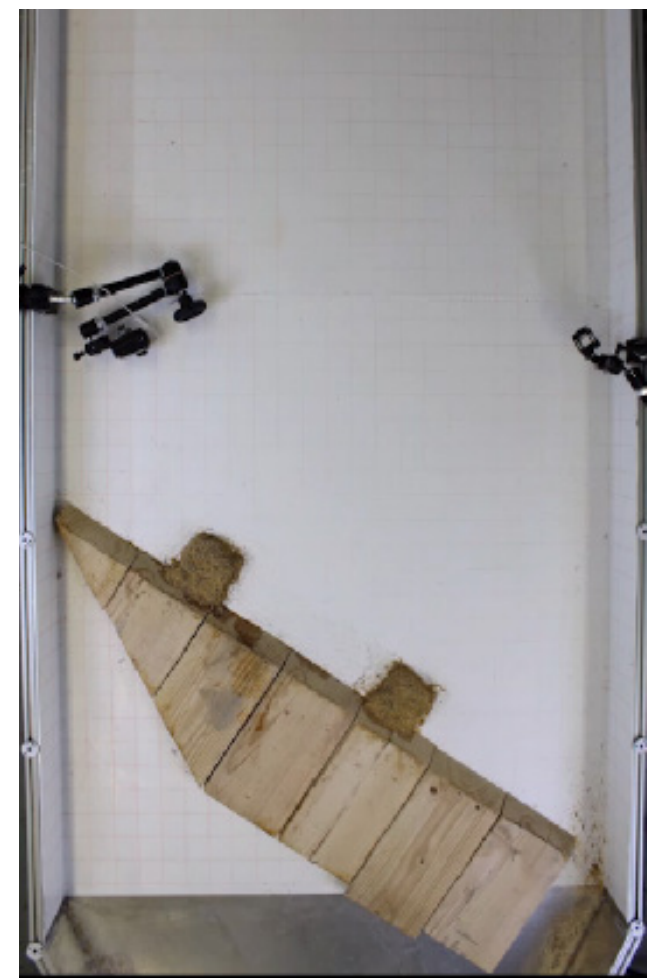
Figure 4.4-1 Iteration Results (Before)

Observationally, a few patterns emerged in all of iteration runs (Figure 4.4-1). Fine sediment tended to be pulled further offshore where it dropped out due to lower velocities. This is commonly described as winnowing. This material created a bell-shaped dispersal pattern around the initial placement. Coarse material dispersed along the shore, creating and adding to the initial beach. A swash zone of newly created material formed from some of this coarse material. This swash zone stayed active during the entirety of the iteration run. The majority of the sediment traveled westward, creating a “tail” of sediment. Ideally, the more material that traveled along the shore (“tail”) would be greater than the material that remained around the initial placement (“bell”)

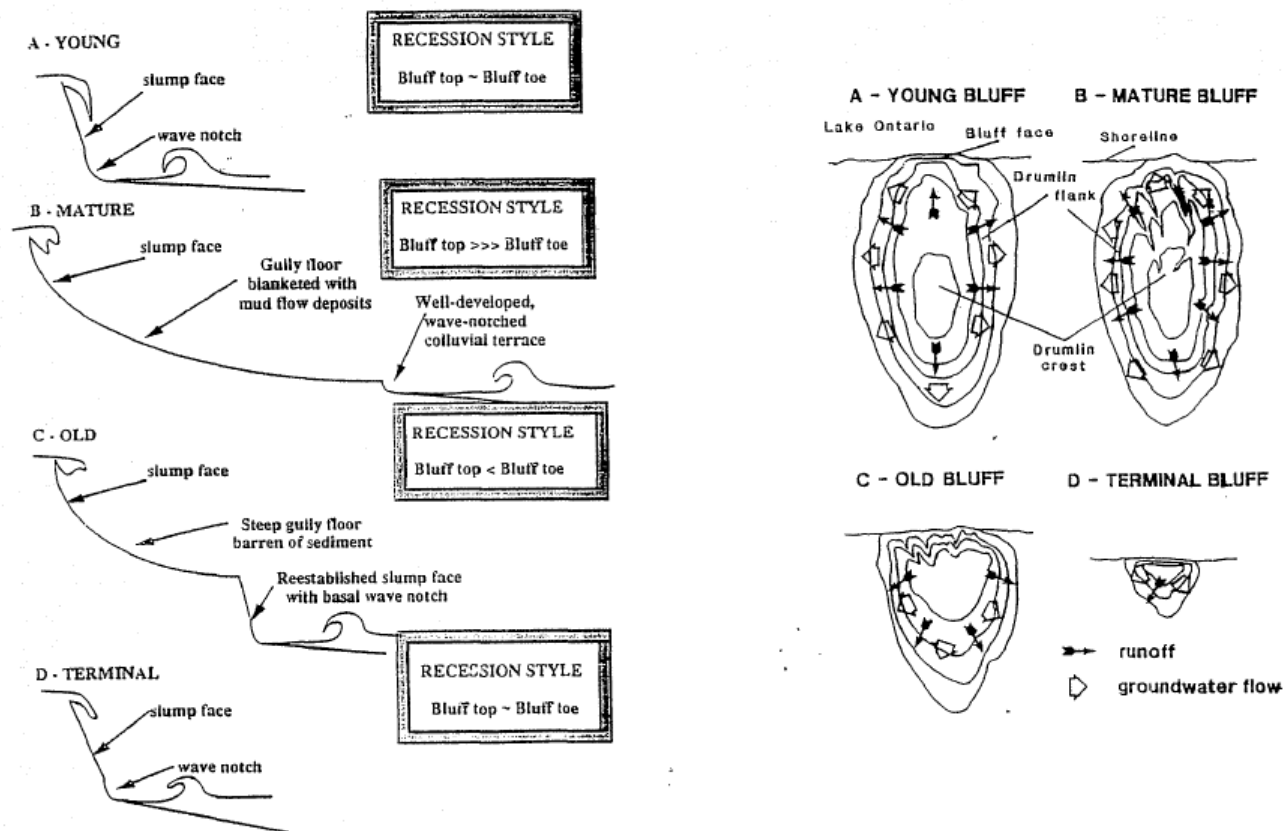
Figure 4.6 Drumlin Erosion (Pinet + McLennen, 1997)

The drumlin shape increased the erosion rate of the pile. The steep side slopes helped facilitate active sediment erosion. This process mimicked the morphological developmental phases of drumlin bluffs seen along the coast (Figure 4.6). Under these conditions, the drumlin undergoes a faster erosion rate, and more sediment to the system in the preliminary, early stage. In a similar manner, in the water table experiments, the erosion rate and dispersal was high early on, and becomes increasingly slower over time (Figure 4.7). In the field, we might expect to see the same dynamics. This is desirable, because the bar might be quickly nourished and then stay relatively stable over the course of the late spring and summer.

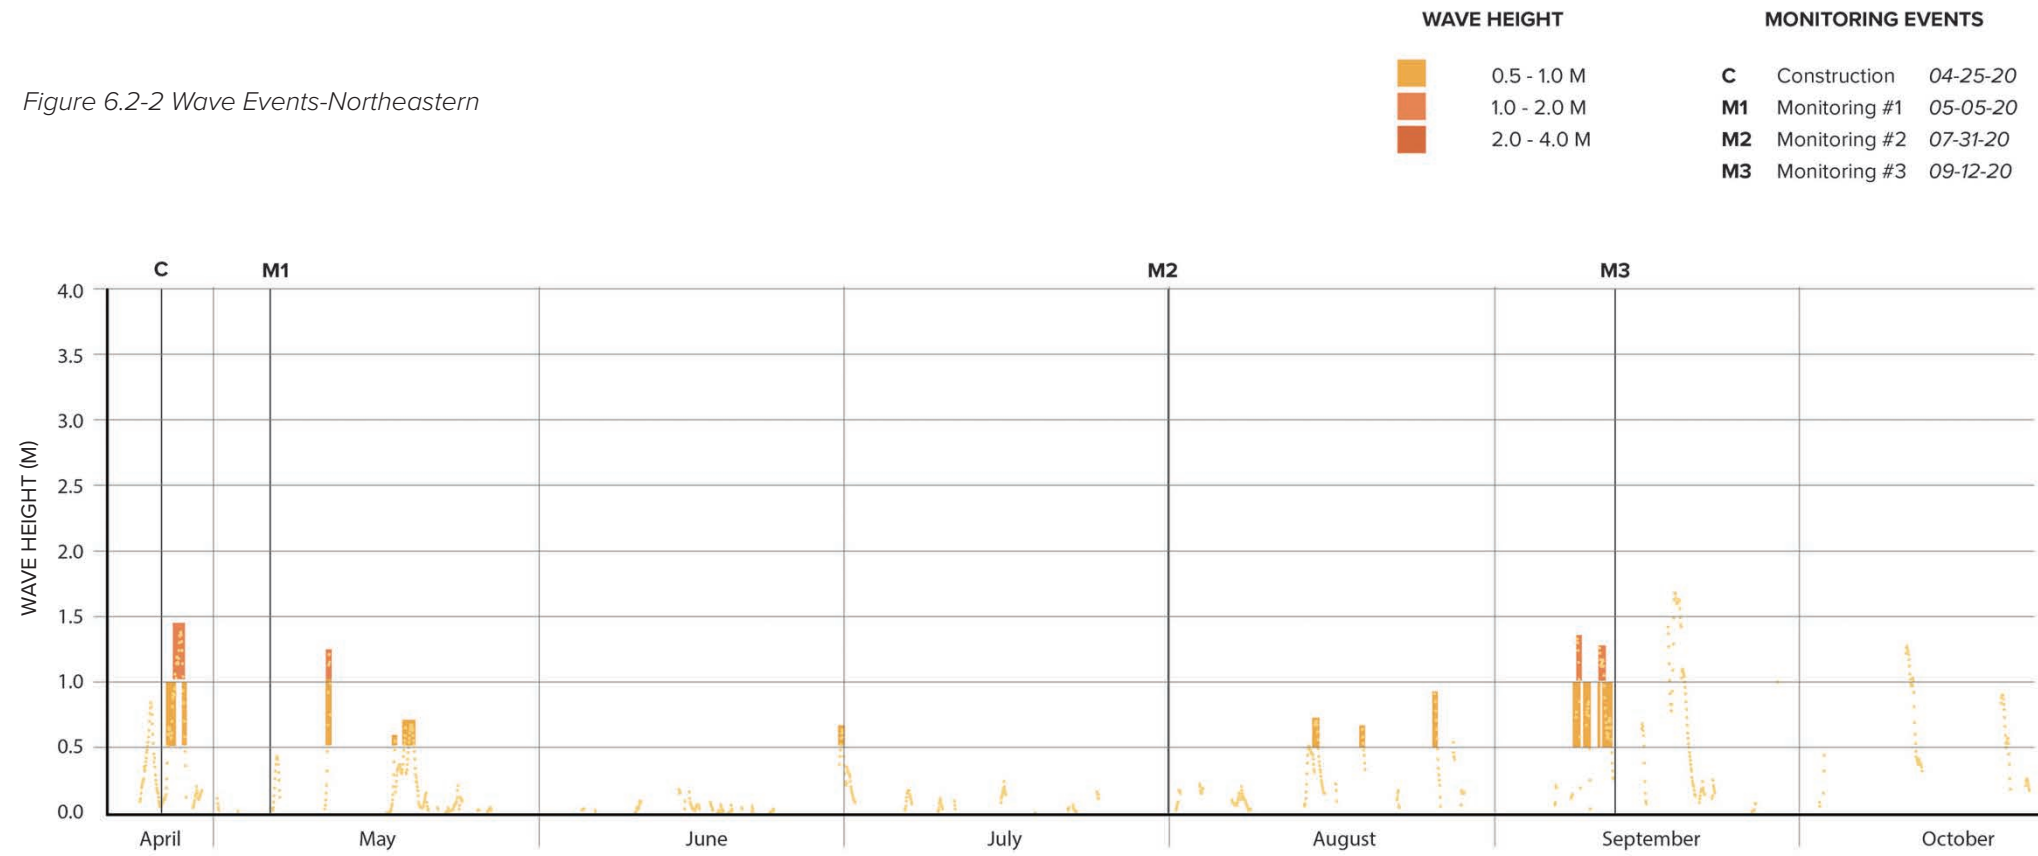
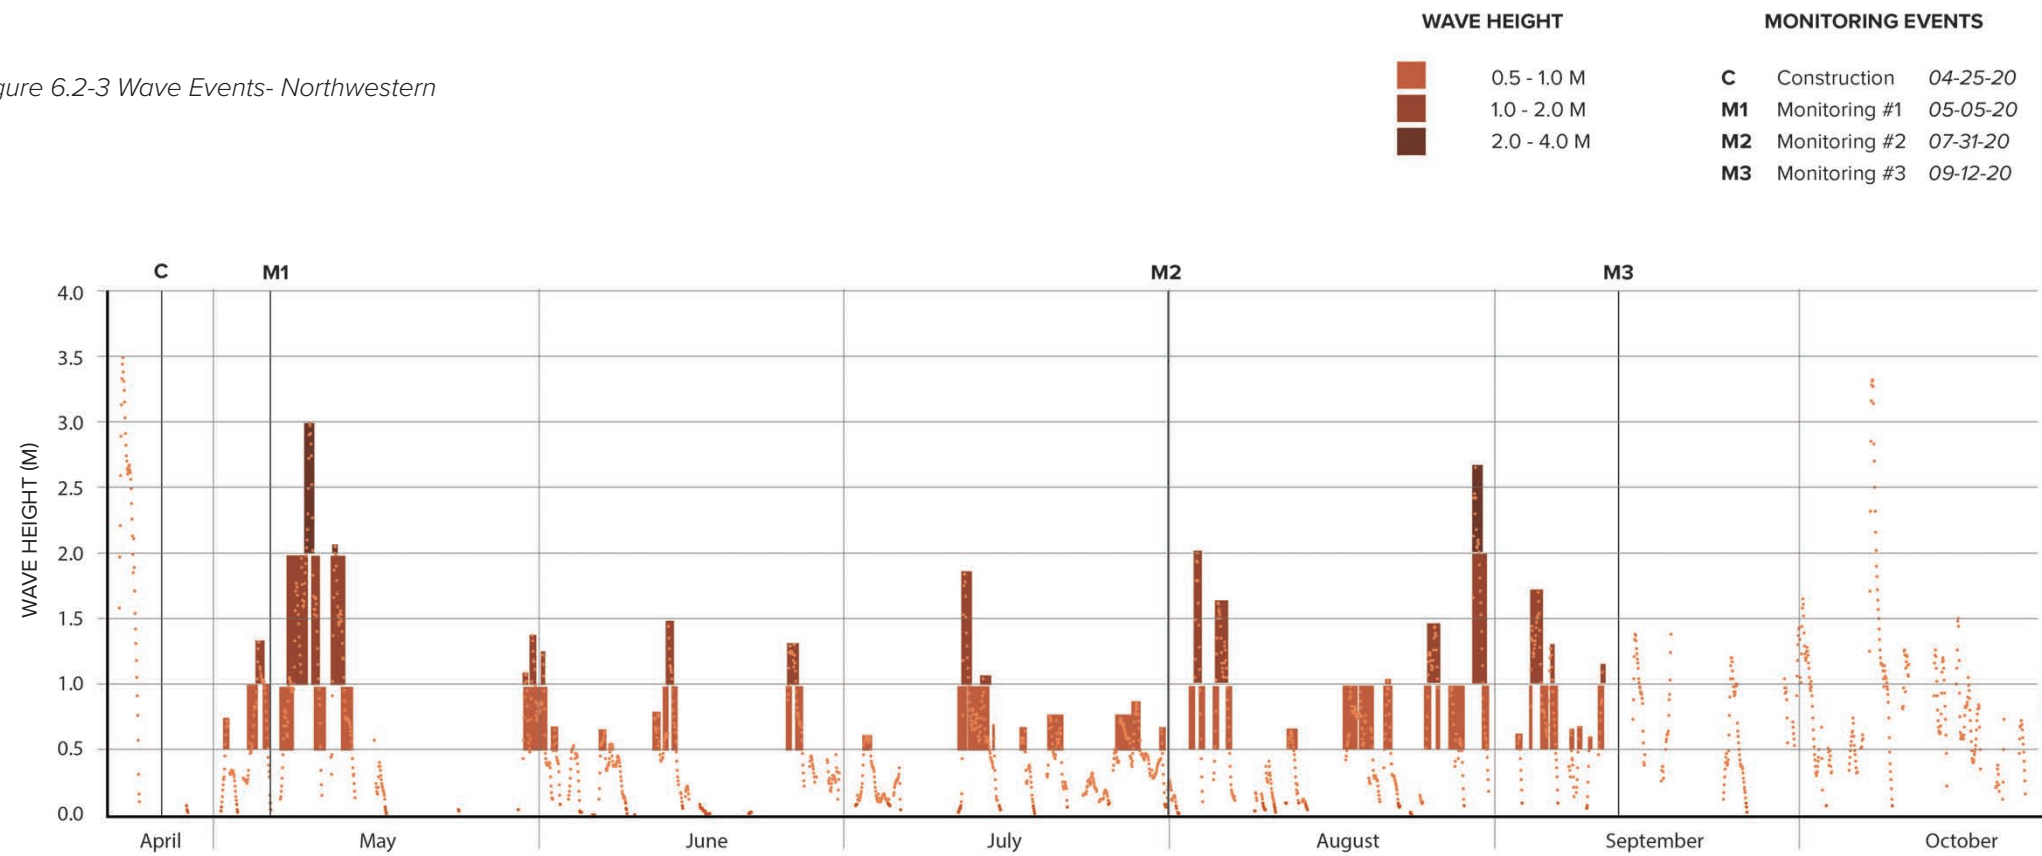
Figure 6.2-2 Wave Events-Northeastern

Data from Great Lakes Observation System- Lake Ontario Forecast. "Virtual buoy" located north of Port Bay @43.3327 °N 76.8411 °W. <https://portal.glos.us/#>.

During those ten days, water levels rose by .2' from 247.15 to 247.35 and small storm wave events from the northwest and northeast (Figure 6.2). On May 5th, when data collection occurred, choppy northwestern waves were observed crashing into the beach.

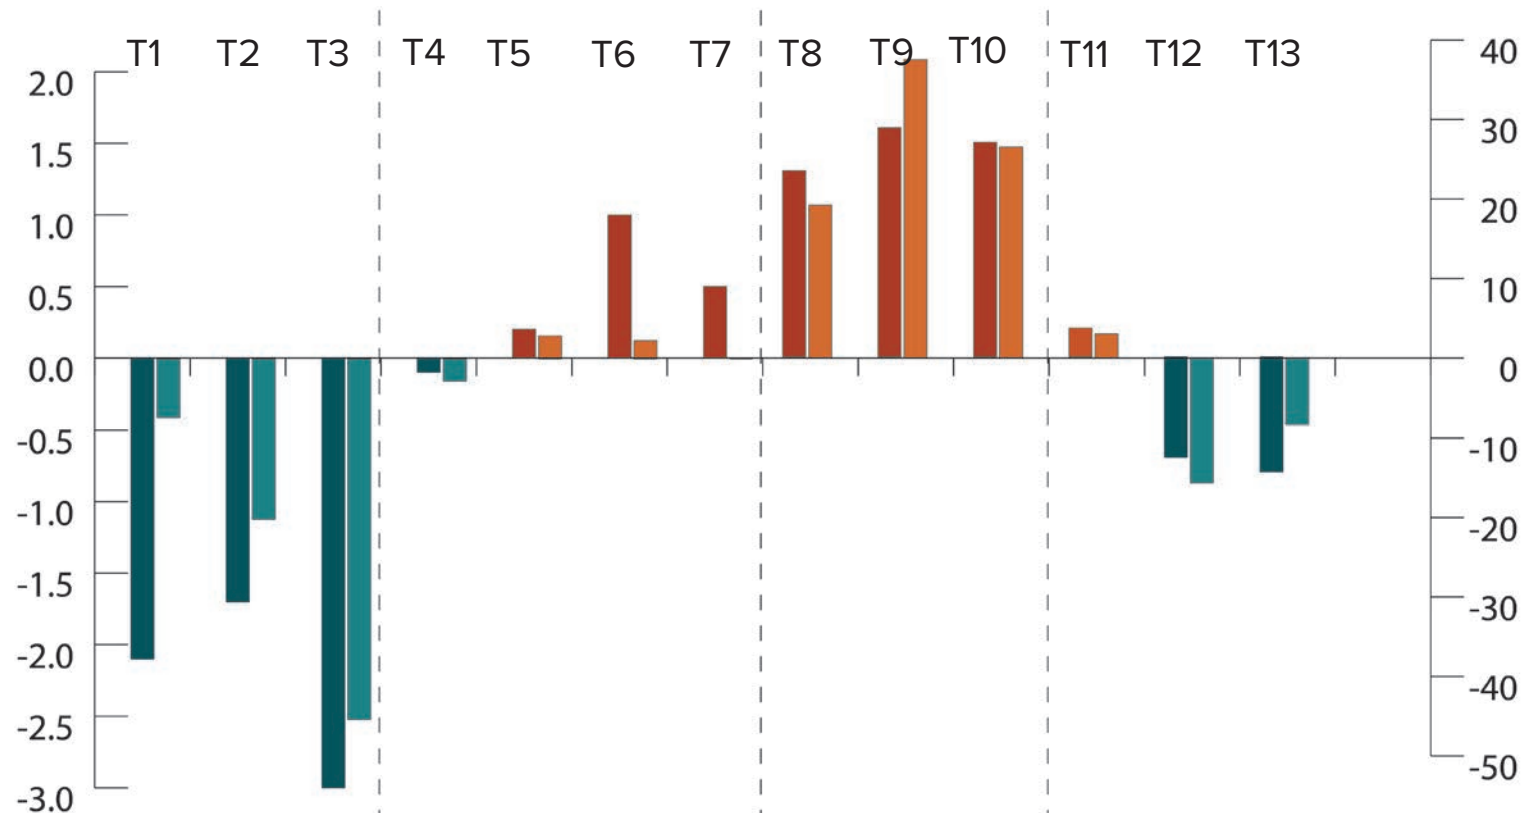
Figure 6.5-1 Transect Graph | April 25- September 12

In summary, between April and September, most of the large wave events occurred from the northwest direction. The westernmost part of the bar eroded since initial placement (Figure 6.5). Much of the initial accretion directly east of the feature eroded four months later, suggesting continued migration across the bar, albeit more slowly. The material continued to migrate eastwards across the bar, filling in concave areas of shoreline. If sediment has travel west of the pocket, the sediment is not enough to offset the erosive wave forces as the area has generally eroded. As can be seen the aerial photography, the base of the feature, thought to mostly be comprised of larger, heavier sediment, has remained. This underground feature is shaped like a bell, and is 97' feet at its widest, and 32 feet past swash zone.
